**FEDERAL AVIATION ADMINISTRATION
AIRWORTHINESS DIRECTIVES
SMALL AIRCRAFT, ROTORCRAFT, GLIDERS,
BALLOONS, & AIRSHIPS**

BIWEEKLY 2004-13

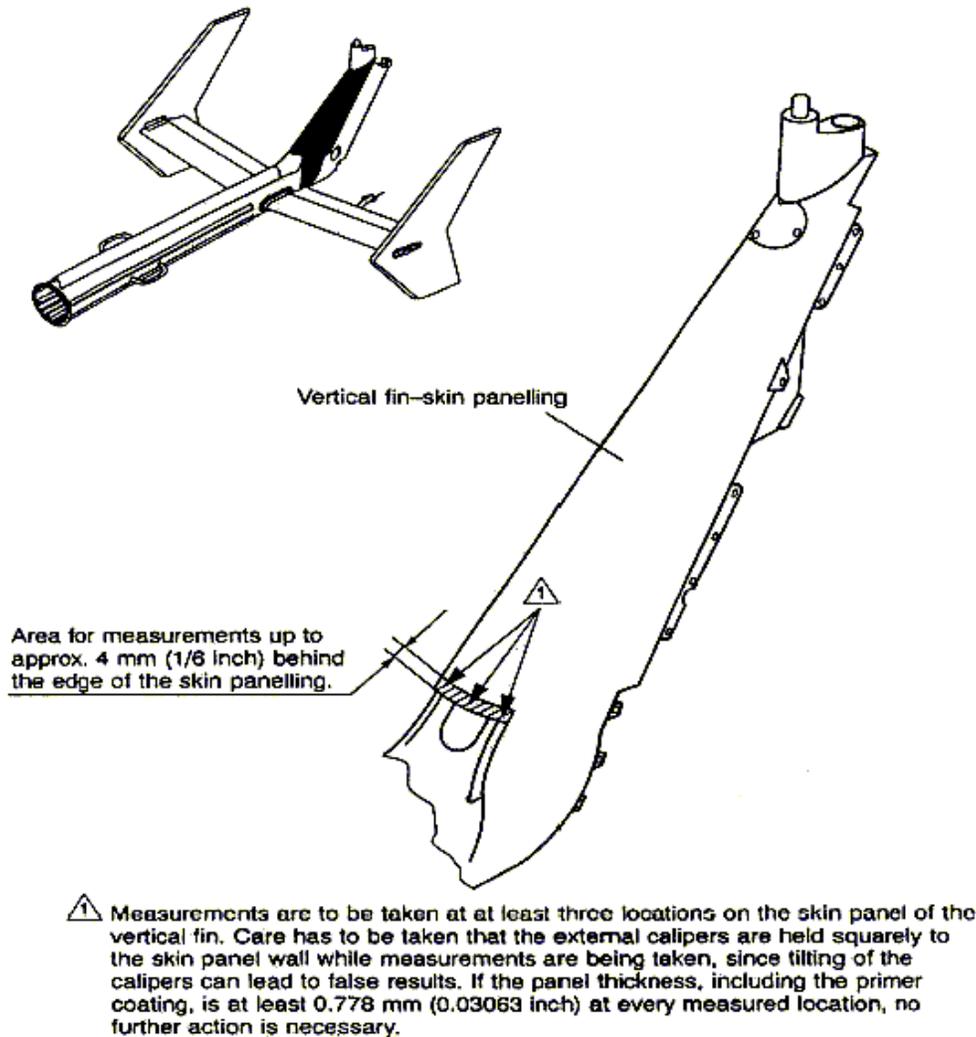
Vertical Fin-Skin Panelling
Figure 1

To prevent failure of the vertical fin and subsequent loss of control of the helicopter, do the following:

(a) Using external calipers, measure the wall thickness, including primer coating, of the skin paneling of the vertical fin at the locations shown in Figure 1 of this AD.

(b) If the wall thickness, including the primer coating, of the panelling is less than 0.778 millimeter (0.03063 inch) at any of the measured locations, replace the vertical fin with an airworthy part before further flight.
